AmeriHome Inspection Services

Property Inspection Report

Any Street, Any Town, VA 12345
Inspection prepared for:
Real Estate Agent: Phil Gamlin - Ahisva

Date of Inspection: 12/30/2015 Time: 10:00
Age of Home: 16 Size: 2994
Weather: Rain

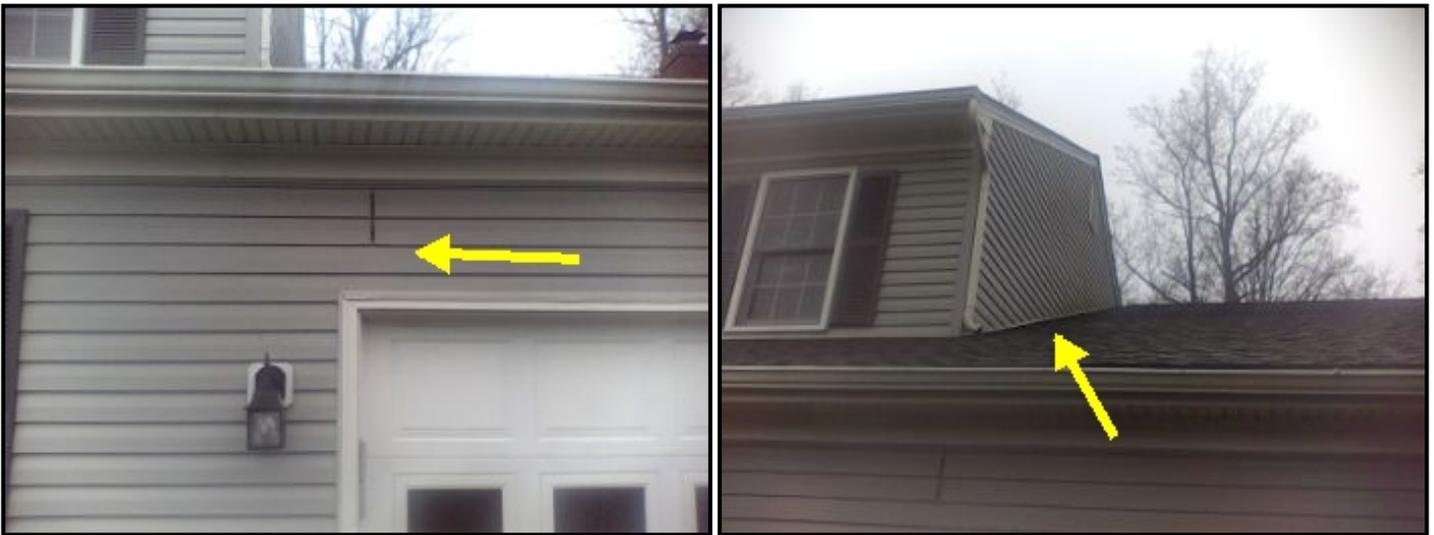
2. Siding Condition

Materials: Vinyl siding noted.

- Siding is weathered, suggest powerwashing to prolong life and remove residue,
- Minor cosmetic repair needed.

Page 3 Item: 2	Siding Condition	<ul style="list-style-type: none"> • Siding is weathered, suggest powerwashing to prolong life and remove residue, • Minor cosmetic repair needed.
Page 3 Item: 5	Stairs & Handrail	<ul style="list-style-type: none"> • Suggest adding stairs built to code at rear basement door and at lower deck.

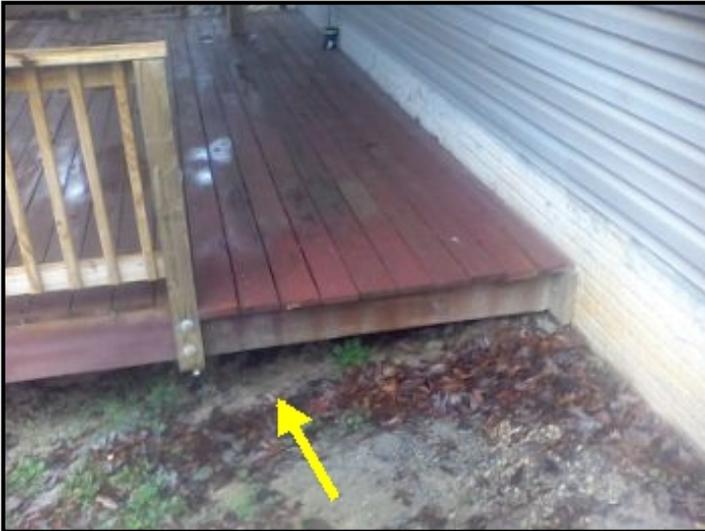
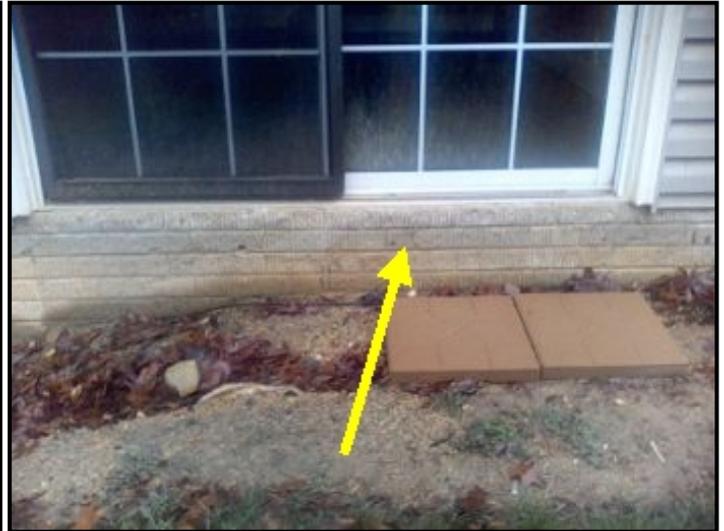
5. Stairs & Handrail

- Suggest adding stairs built to code at rear basement door and at lower deck.

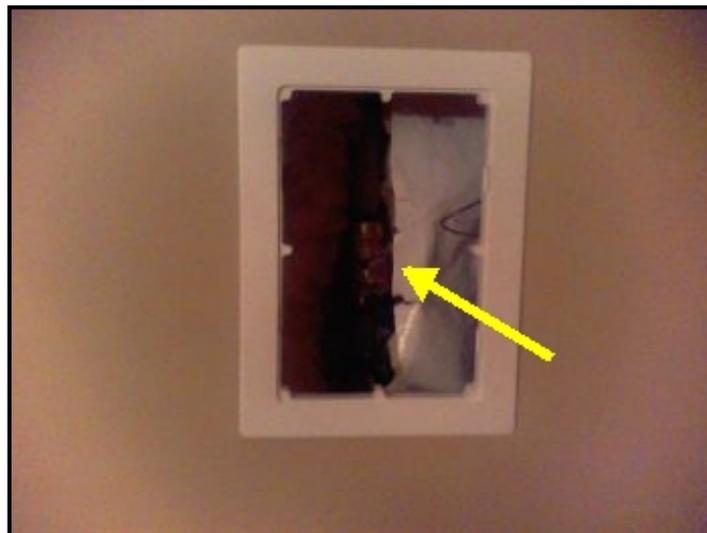
3. Plumbing Materials

- Plastic

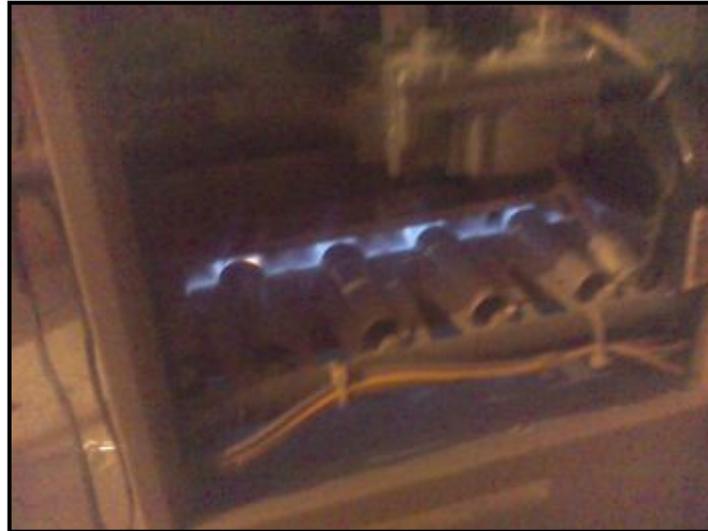
6. Gas Valves

- Gas shut off valves were present and functional.

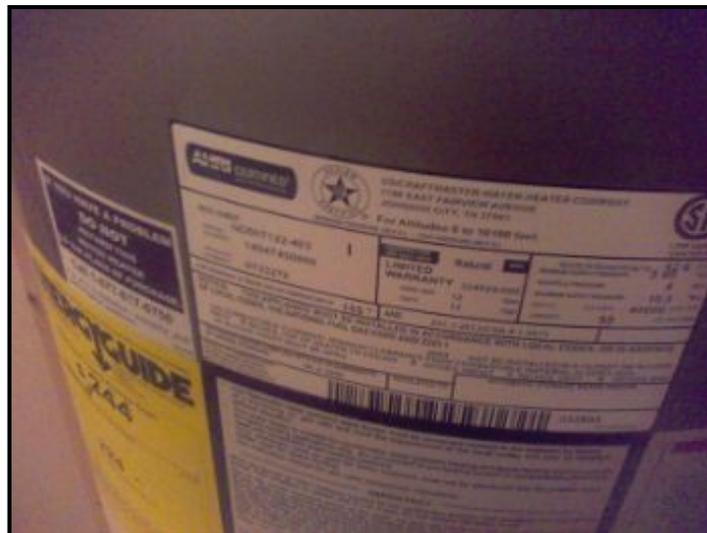
4. Water Heater Condition

Heater Type: Gas

Location: The heater is located in the basement.

- Tank appears to be in satisfactory condition -- no concerns.

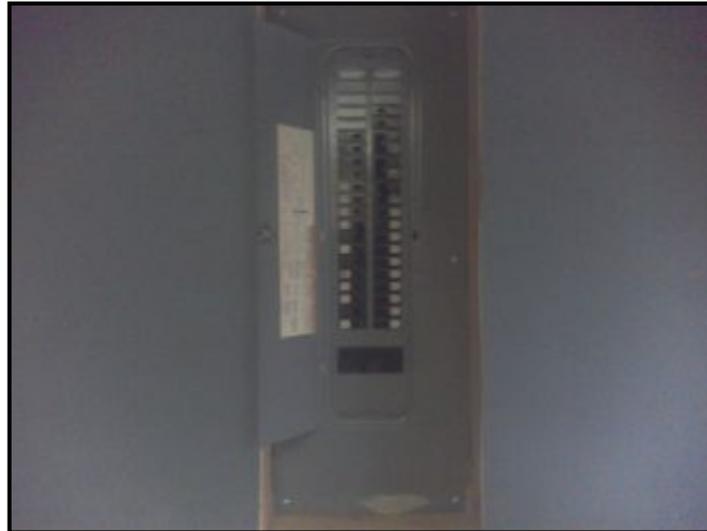
1. Electrical Panel

Location: Panel box located in basement.

- No major system safety or function concerns noted at time of inspection at main panel box.

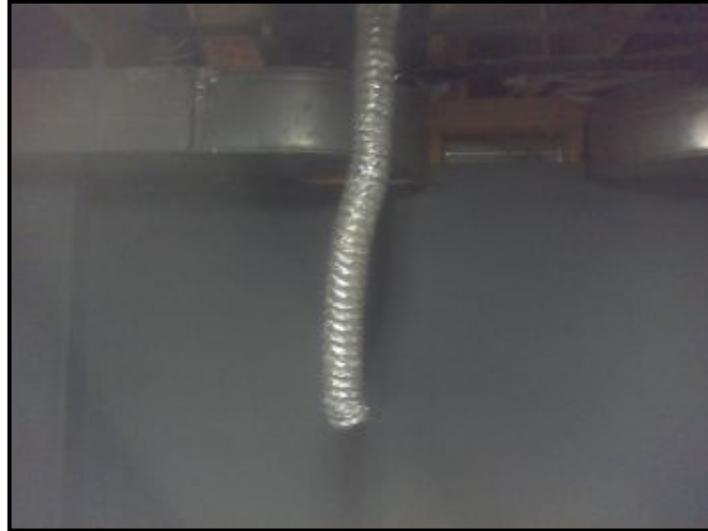
1. Exhaust Fan

- The fan terminates improperly in the basement This can create excessive moisture. Recommend directing the vent towards the exterior to allow for proper ventilation.

Page 17 Item: 1	Exhaust Fan	<ul style="list-style-type: none"> • The fan terminates improperly in the basement This can create excessive moisture. Recommend directing the vent towards the exterior to allow for proper ventilation.
-----------------	-------------	--

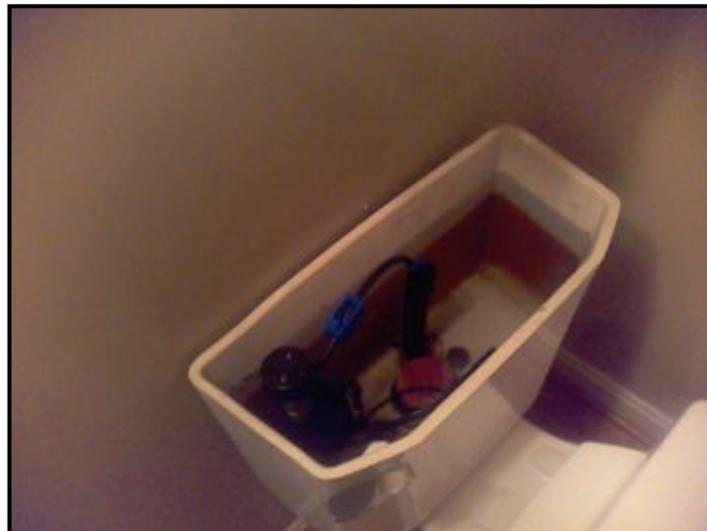
- Toilet continues to run after flushing; have contractor evaluate and repair.

• Toilet continues to run after flushing; have contractor evaluate and repair.
